CITY OF LYNDEN

STORMWATER MANAGEMENT PROGRAM

2017 WATER QUALITY MONITORING REPORT

MARCH 29, 2018

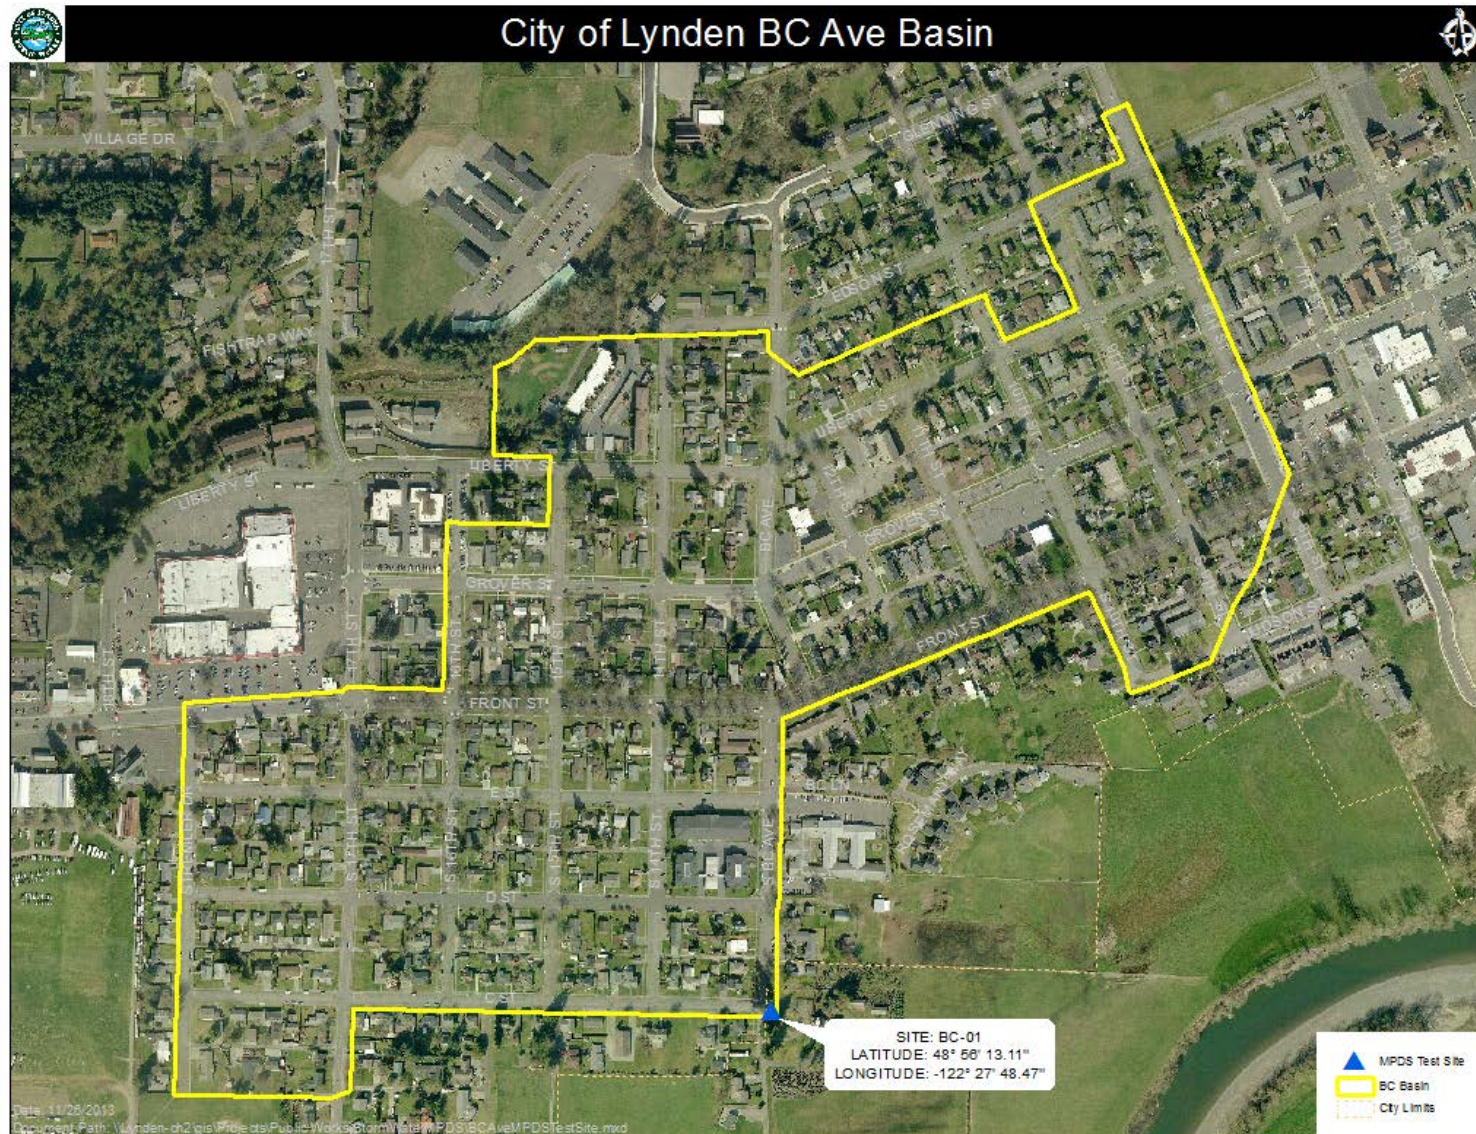
Figure 1: BC Avenue Outfall Drainage Area

After careful consideration, the City prioritized the BC Avenue subbasin (Figure 1) as representative of the City's contribution of fecal loading to the Nooksack River. The selected outfall is located south of Fishtrap Creek draining a portion of the southwest part of the City and

abutting the Northwest Fair Grounds to the west. The land uses that drain to this outfall are dominated by single family residences, some multiple family units and condominiums as well as a few miscellaneous services such as churches, assisted living units, and professional services.

The sample site location, Station BC-01, is located in a manhole at the southeast corner of South BC Avenue and C Street; Latitude N48° 56' 13.11" and Longitude W122° 27' 48.47" close to the City boundary. The City's stormwater network draining to this BC Avenue outfall is approximately 117 acres. The outfall is a 54" deep manhole with no logistical access problems. From the manhole, the 15" pipe daylight to a county ditch system and is conveyed to the Nooksack River. This lower area is under Whatcom County's jurisdiction and is occupied by hobby farms.
